ADVANCE REPORT  
on the  
SEDIMENTATION SURVEY AND SUSPENDED-MATTER  
OBSERVATIONS IN LAKE ISSAQEEENA  
CLEMSON, SOUTH CAROLINA

1940 - 1941

G. A. Zwerner, J. W. Johnson  
and  
E. M. Flaxman

Sedimentation Section  
Office of Research  
SCS-SS-37  
November, 1942

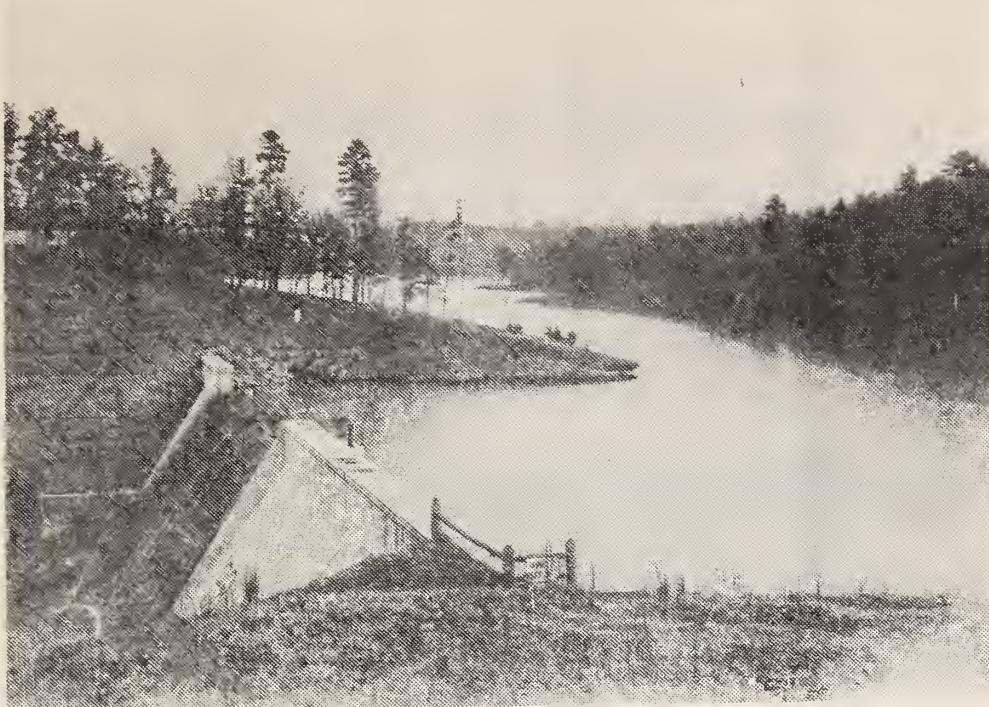
Figure 2.--View of Lake Issaqueena Dam and spillway, showing the well-sodded and heavily wooded shore line.

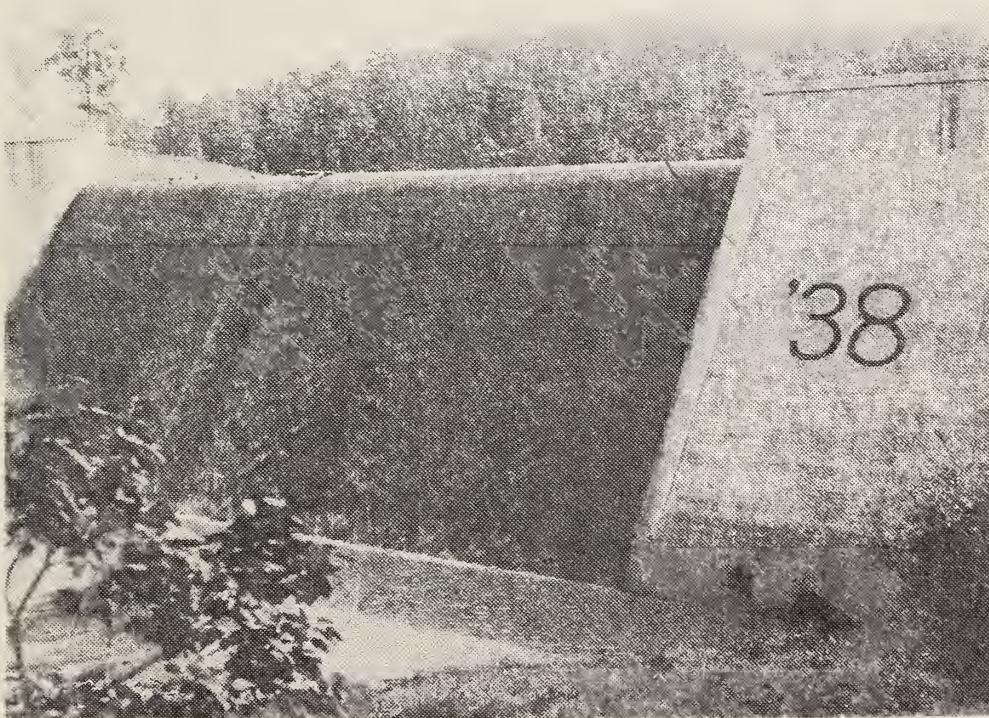
One 30-inch corrugated iron pipe sluiceway and one 24-inch steel pipe penstock are located in the dam with the center of each orifice 34 feet below spillway crest. The discharge through these outlets is controlled by manually operated, rectangular, cast-iron gates located on the upstream face of the dam (fig. 3).

Figure 3.--View of the downstream side of Lake Issaqueena Dam, showing outlets of the two gates.

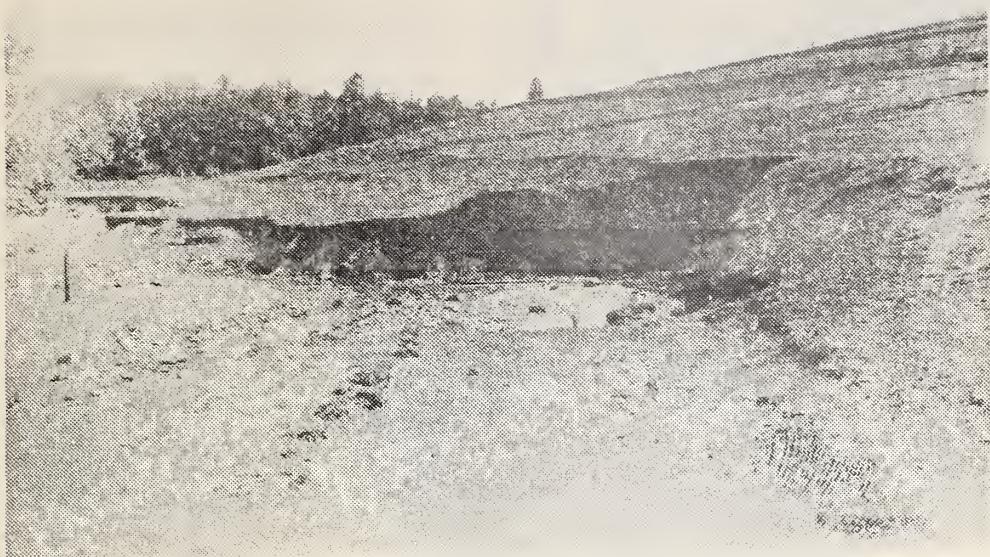
The characteristics of erosion in the area are further described in a report by Hugh A. Brown<sup>2</sup>, which shows that moderate stream-bank and serious road erosion is occurring in the watershed. It was found that 21,186 linear feet of banks on the main stream and three of the main headwater tributaries were caving badly, the major cause being cultivation or pasturage of land adjacent to the channel. Roads, road banks, and road ditches were found to be major sources of reservoir sediment, an estimated 175,990 feet or 33.3 miles being in need of protection. Serious gullying occurs only in ditches along farm or field boundaries. The location of roads and stream banks requiring treatment is shown in figure 5, and examples of these processes are shown in figures 6 and 7.

Figure 6.--Stream channel with eroding banks, one of the principal sources of reservoir sediment from Lake Issaqueena watershed.

A survey of the Lake Issaqueena watershed and a bried reconnaissance by the writers have given definite indication that two major sources of reservoir sediment are: Poorly maintained roadside ditches that have caused severe erosion in adjacent farm fields and destroyed large sections of the roads themselves, and unprotected stream banks which, during the high intensity flash floods of the late summer months, are very susceptible to caving and washing. Sheet and gully erosion also have an important part in supplying the streams and creeks with a heavy sediment load. A well rounded erosion control program in this watershed, including road and gully control and stream bank treatment, would materially reduce the sediment load reaching Lake Issaqueena. In addition, it would improve the value and productiveness of the farm lands, as has been widely demonstrated in the Soil Conservation Districts of the State in recent years. Such a program, with its twofold justification in this small area, should be started at the earliest possible date.

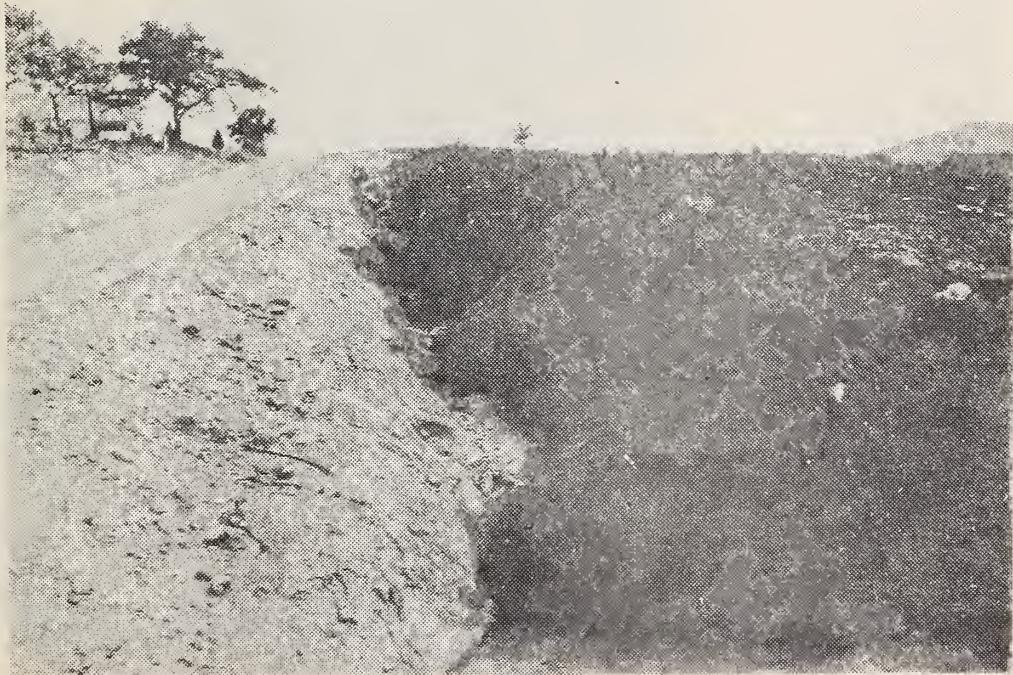
Figure 7.--Roadside erosion in Lake Issaqueena watershed, one of the major sources of reservoir sediment.
